Log ~~2550~~  
**National Transportation Safety Board**

Washington, D.C. 20594  
**Safety Recommendation**

Date: July 3, 1995  
In reply refer to : A-95-68 through -70

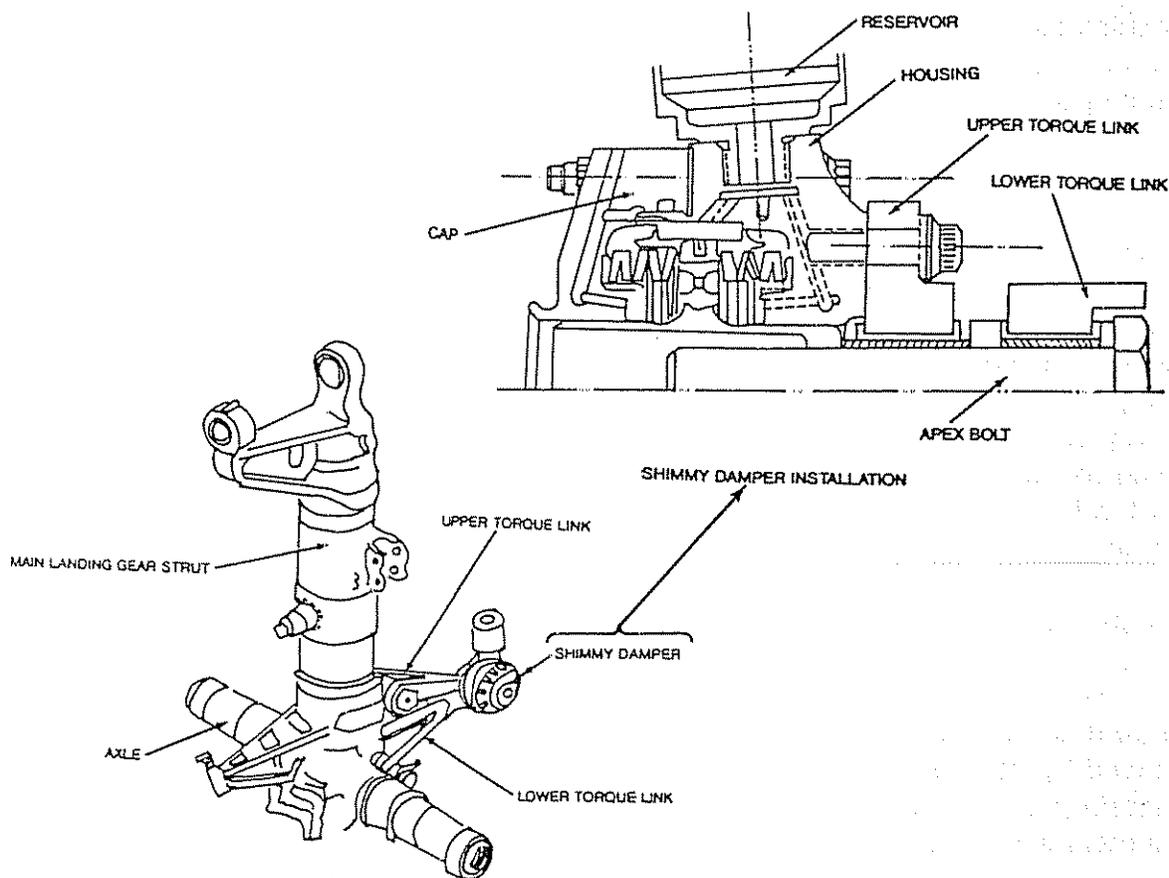
**FIGURE 1. MAIN LANDING GEAR SHIMMY DAMPER ASSEMBLY**

Postaccident examination of the wreckage was conducted by the Finish Civil Aviation Administration (CAA) and the Douglas Aircraft Company (DAC) in Kajaani, Finland. The examination of the wreckage showed that the LMLG shimmy damper remained attached to the landing gear structure, and the shimmy damper reservoir had separated along with the upper and lower torque links. The RMLG upper and lower torque link arms had also separated. The RMLG's shimmy damper remained attached to the upper torque link, but the reservoir had separated. Threads on the right apex bolt were found stripped, and both the right and left apex nut were found on the runway with bolt threads stripped.

The McDonnell Douglas MD-80 and earlier DC-9 series airplanes are configured with shimmy dampers, which provide torsional/lateral vibrational stability to the landing gear during the landing roll (see Figure 1). The upper torque link is connected to the main stationary strut, and the lower torque link is connected to the compressible strut. Both the upper and lower torque links are connected to a shimmy damper with a single apex bolt. The upper torque link remains stationary, and the lower torque link moves laterally along with the apex bolt to provide a lateral damping movement.
